Study of Power Quality: Problems in Commercial Buildings in Puerto Rico

Eduardo I. Ortiz-Rivera, *Student Member, IEEE*

II. CASE OF STUDY I - HOME DEPOT MAIN BREAKER

IV. CASE 3 - ELECTRICAL SYSTEM ANALYSIS FOR CITIBANK CENTER

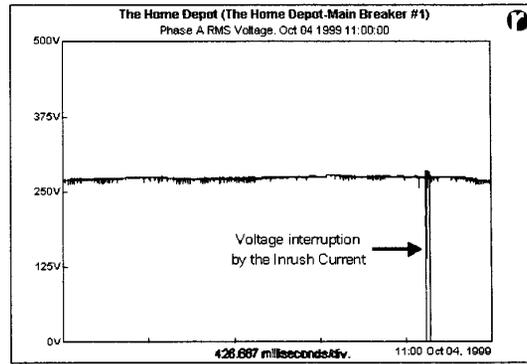
Fig. 1. Voltage Phase A Spikes

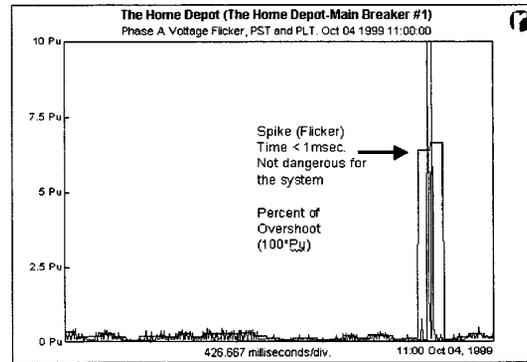
Fig. 2. Phase A Percent of Overshoot (100*Pu)

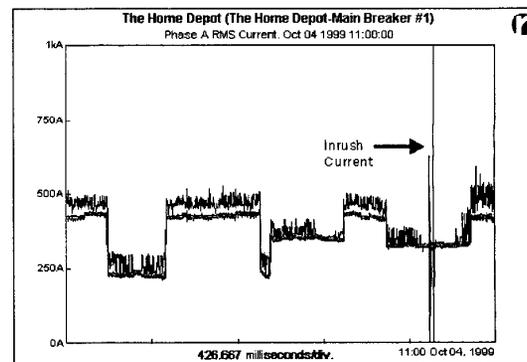
Preliminary results: Possibility of high inrush current when power is re-established. Inrush current (Flicker Effect) may exceed current rating of the Main Breaker Fig. 3.

The problems with the inrush current occurred because the use of electric loads drastically increased creating overshoot for short time. The spike was faster than the operation of the breaker; hence, the substation breaker tends to trip. But this type of spike does not represent any danger to the system. Using Fourier analysis of the voltage phase A, the current phase A, and the ground currents, the analysis reflects that there are a lot of harmonics, due to noise created for the loads Fig 1-Fig 3. These harmonics are the result of the interaction of the environment noise and magnetic nonlinear loads. For this system, the production of harmonics could also be due to the size of the neutral line.

The event with the inrush current was directly related with the tripping of the breakers. This event occurred when the Air Conditioner was starting. If the inrush current of the HVAC is more than the current rating of the breakers, the result is that the breakers will trip.

Fig. 3. Phase A Inrush Current

Final results: The time of delay on the breakers was changed. Originally, the Delay Setting was set at 2 s and the Short Delay Time was set on 1 s. Now, the Delay Setting is 4 s and for the Short Time Delay is 0.3 s. This is a temporary solution to solve the inrush current problem.

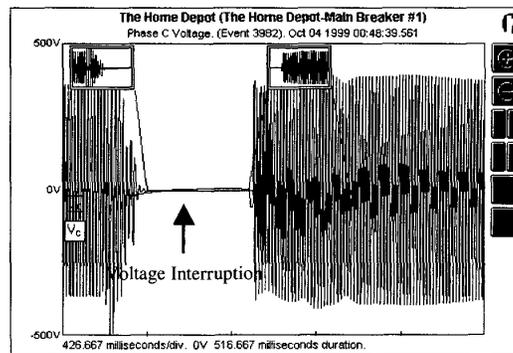
The noise produced could be produced by interactions of telephone lines with power lines. The effects of the interactions of the harmonics and the inrush current are shown in Fig. 4 for Phase C. It shows a voltage interruption created by the inrush current when the Main Breaker trips. A voltage interruption will affect the power factor creating distortion. The distortion creates power losses leading to additional money that companies need to pay to the Electric Service Utility.

Fig. 4. Voltage Phase C after Inrush Current

Permanent implemented solutions for these types of problems are Shielded Isolation Transformers with K-factor protection; the SIT's are very useful for a 60Hz and high frequency grounding system bonded together, or, if

the electric loads are very sensitive, it should be connect an IG Receptacle to reject the noise to the loads. Another solution is to resize the neutral conductor reducing the current density [7], [9].

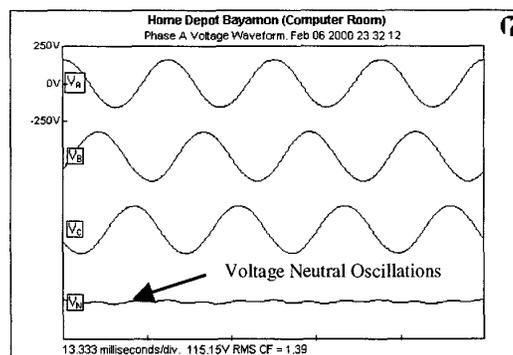
Fig. 5 shows the Voltages A, B, C and Neutral in the UPS in the Computer Room. The Neutral Voltage is zero for a symmetric balanced three-phase system [6], but in Fig. 5, it is shown that the Neutral Voltage has oscillations resulting in an unbalanced system and the harmonics injection in the ground current and losing the data transferred. If the ground current is not zero, the power losses are created in the form of harmonics. The Fourier analysis is shown in Fig. 6. The harmonics will interrupt the data transferring communication.

Fig. 5. Voltages in the UPS on Computer Room

telephone lines and other elements interacting between them creating noise, it looks with oscillations. These oscillations are created by the mutual inductance and resonance between the UPS, telephone lines and the computers. Finally with the use of the CBEMA Curve, Fig. 7 presents the events that affect the transfer data can be identified, in this case when the emergency generator

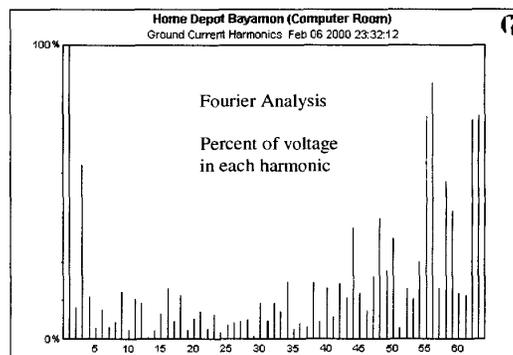
Fig. 6. Ground Current Harmonics in the UPS

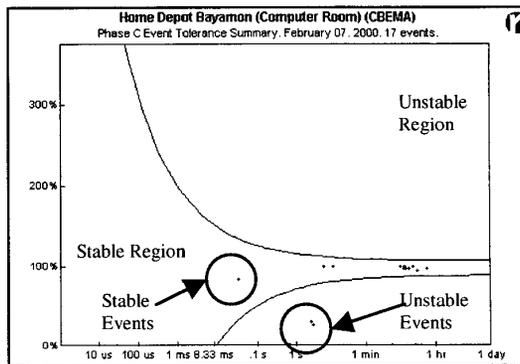
runs on exercise mode. The stable region represents the maximum and minimum tolerance for the voltage allowed after turn on power across the time. The unstable events represent when the emergency generator starts to run on exercise mode. Each event is a voltage drop or increase of the nominal voltage. For the solution to resize neutral, it needs to be 1.73 times the phase conductor ampacity in a 208/120V shared neutral system [9].

Fig. 7. CBEMA Curve
